# CASE STUDY: CSMETER FINDS BROKEN ROTOR BARS IN CONDENSATE PUMP MOTOR

## BACKGROUND

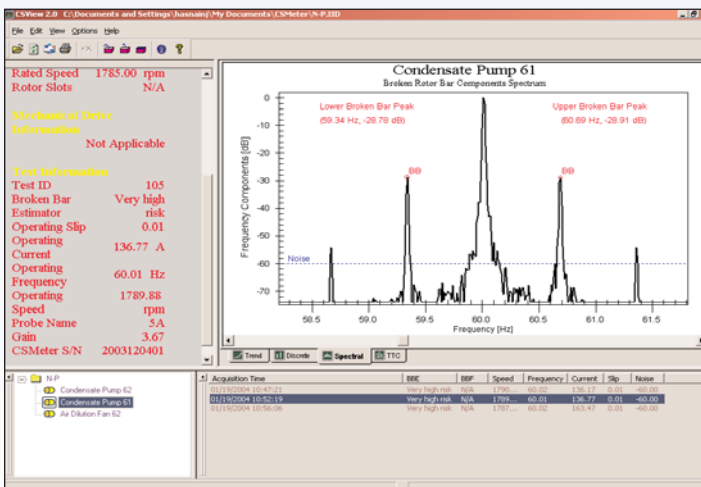
The data was later downloaded to a PC and the graph from the analysis software is displayed in Figure 1. The CSMeter had showed the running speed to be 1789.88 rpm and the load current at 137A (60% full load current) that is also reflected in Figure 1.

Note that the sidebands due to broken rotor bars have been marked "BB" (short for broken bars) in red. The frequency positions of the two symmetrical sidebands due to broken rotor bars are indicated at 59.34Hz and 60.69Hz. Also note the skirting effect at the base of the supply frequency spike due to load fluctuations and the presence of harmonics of the sidebands at 58.67Hz and 61.36Hz.

The dB difference between the fundamental frequency and each sideband is marked at 28.78dB and 28.91dB. The diagnosis of "Very High Risk" (see Figure 1, BBE or the Broken Bar Estimator) is based the average dB values of the two sidebands since, for this motor, the number of rotor slots/bars was not known. Had the latter been known the CSMeter would have provided an estimate (BBF, or the Broken Bar Factor) of the number of bars broken.

Figure 1: Screen capture from CSView analysis software showing test data, test list, spectrum and organization tree

The customer was informed of a very severe case of broken rotor bars and was advised to take the motor off-line to avert an in-service failure.
