# END- WINDING DISCHARGE SIGNIFICANT REDUCTION IN PD LEVELS AFTER REPAIR

**Company:** BC Hydro  
**Ratings:** 239 MVA, 13.8 kV, Air Cooled Hydro Generator  
**Manufacturer:** Confidential  
**Related Info:** 37 years old  
**PD Sensors:** Six PDA Couplers per phase

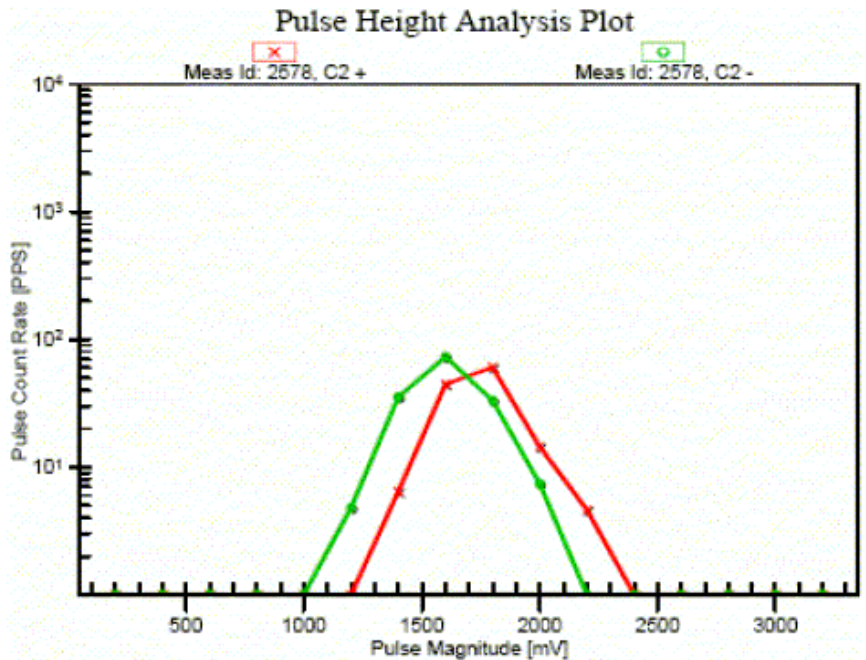
Figure 1. 2D PD Plot Showing Hump at High Magnitudes – Phase C

**Details:**  
 "... This winding was subjected to PD activity in the end-turns of the winding... In the 2D PD plot, it can be seen that a large hump appeared at high magnitudes in both the positive and negative PD activities... The winding was repaired by cleaning the 10 bars closest to the PD couplers; these bars were coated with red glyptal epoxy. After the repair, trending of HydroTrac data showed a significant reduction in PD levels as shown in Figure..."

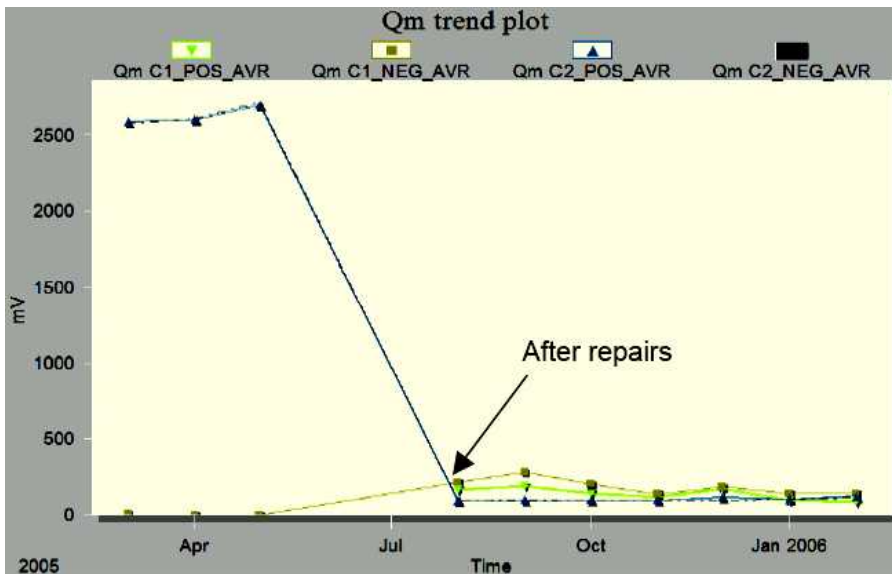
Figure 2. Trend of PD activity – Phase C
