## **CASE STUDY: TGA test finds endwinding contamination problem in turbine generator.**

**Company:** Nevada Power Company

**Unit:** Clark 5 gas turbine generator

**Ratings:** Air cooled, 94 MVA, 13.8 kV 3600 RPM, Epoxy-Mica

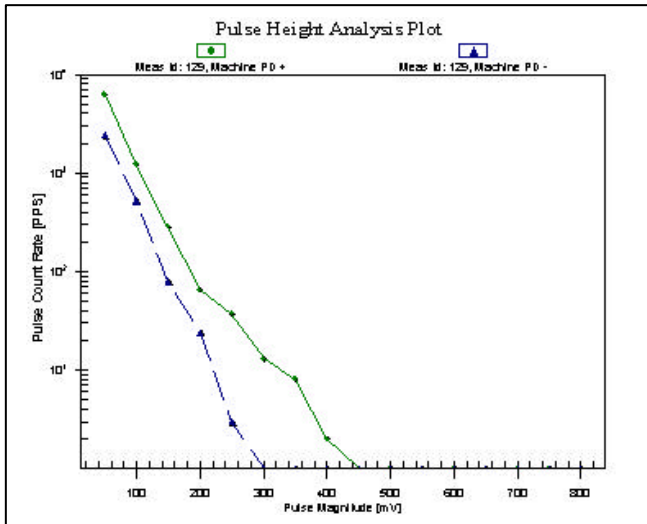
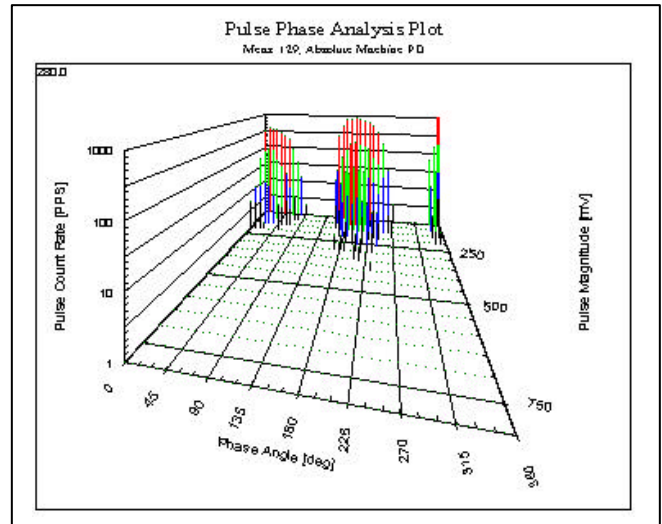
Figure 1 – October 1995 (Classic PD position with positive predominance.)

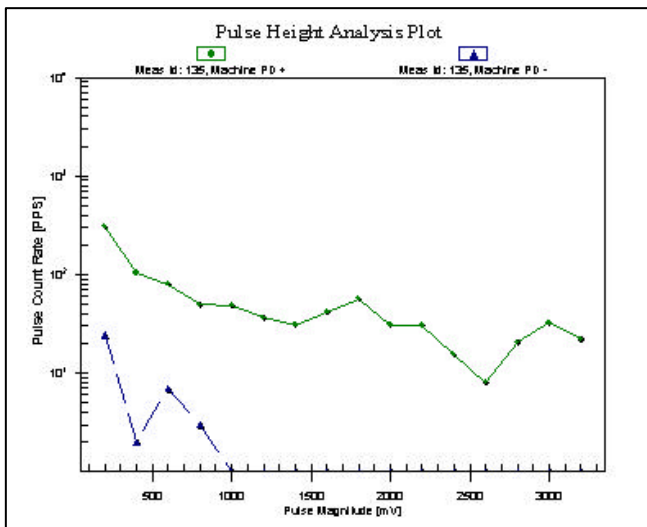
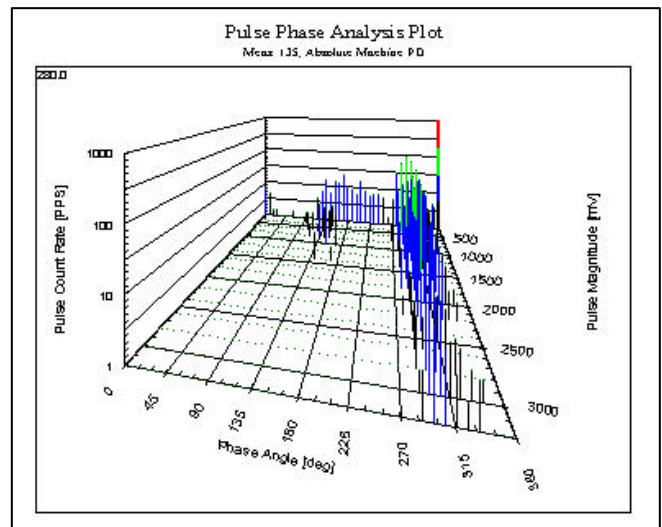
Figure 2 – August 1997 (Note scale and non-classic position indicative of phase-phase activity.)

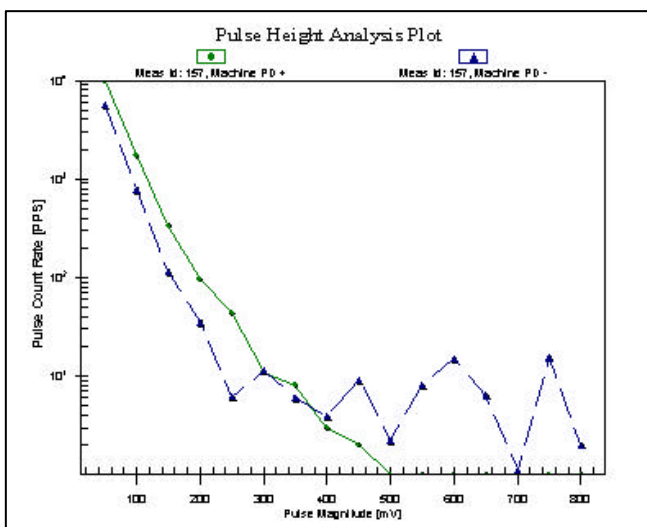
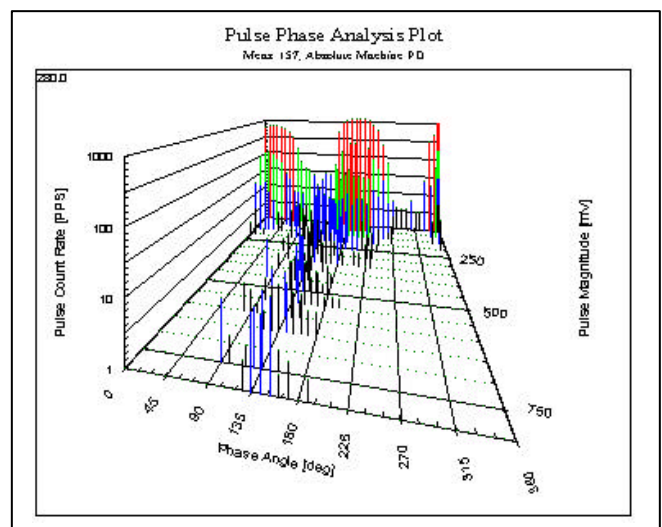
Figure 3 – December 1997 (Still indicating phase-phase but at markedly improved levels. Note the scale change from Figure 2)
