# HIGH RESISTANCE CONNECTIONS DETECTED BY ON-LINE PD IN MOTOR

**Company:** An US oil refinery  
**Ratings:** 20.5 MW, 13.8 kV Motor  
**Manufacturer:** Confidential  
**PD Sensors:** One Bus Couplers per phase  
**PD Instrument:** TGA-B portable instrument  
**Details:**

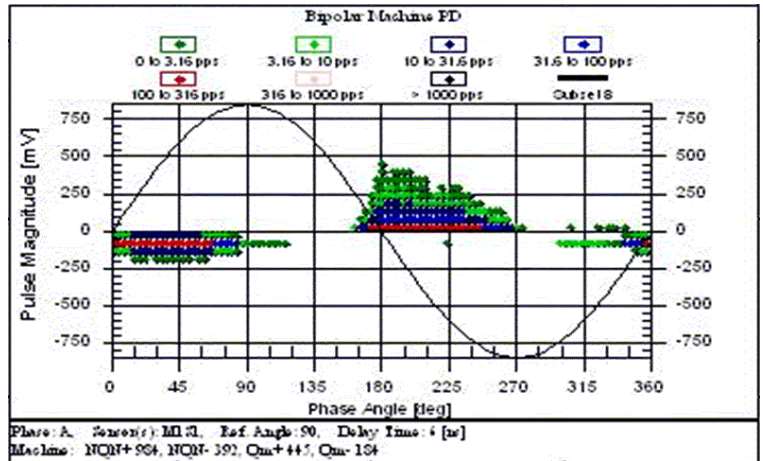
Figure 1. Peak PD levels at 180°

On-line PD tests were indicating high levels of activity at the zero line to ground voltage crossing (angles of 0° and 180°) on one phase (Figure 1). This can result from:

- ❖ Degradation of the semi-conductive coating material at the slot ends, or the interface between this and the grading material in high voltage coils at or near the slot exits, or
- ❖ Loose or oxidized connections near the line ends of the stator winding.

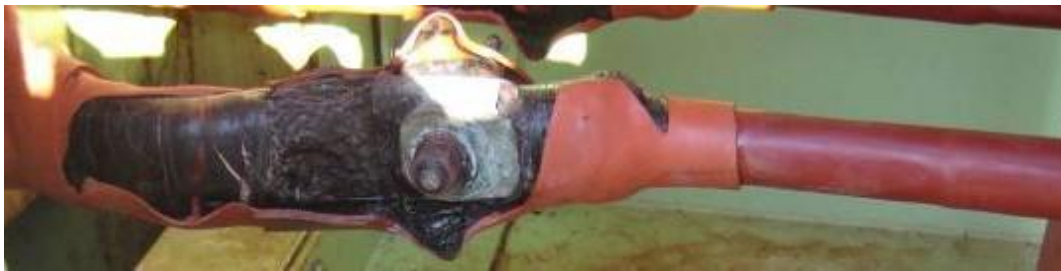
Figure 2. Overheated Connections in Motor Terminals

The motor was shut down for further investigation. Overheated bolted connections were found at the winding line and neutral ends (Figure 2 & 3). A failure in service was thus averted. Off-line testing confirmed the rest of the stator winding was in good condition.
