CASE STUDY: On-line Partial Discharge Testing Confirms Effectiveness of Repairs To 6.6kV Air-cooled Motor

Company: Texas utility
Plant: Nuclear
Unit: Confidential
Ratings: 6.6 kV, 2500 HP, 257 RPM
Manufacturer: Confidential
Related Info: Epoxy-mica insulation, manufactured in 1975
PD Sensors: 3 EMC's

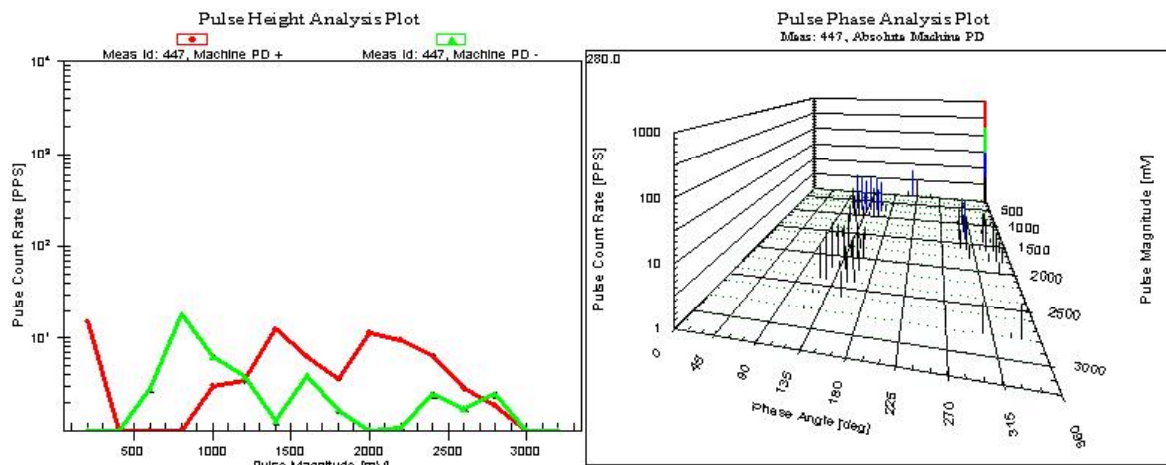
Figure 1. Online Partial Discharge Test September 2001

Details: In September 2001 a periodic test with a TGA-B instrument was done and plant personnel noted extremely high PD activity as compared with the Iris database. Iris Power Engineering provided an informal analysis. The patterns indicated “non-classic” partial discharging between the high-voltage components of the ‘B’ and the ‘C’ phases, along with an unusual grouping on the ‘B’ phase plot that was 180° out-of-phase. These patterns were all cross-coupling to the ‘A’ phase.

At magnitudes in excess of 2000 mV, this PD would be considered extremely high for an air-cooled machine of this voltage class. Subsequent periodic testing showed the continued presence of high-magnitude, non-classic PD. Therefore, this was not an intermittent or transient problem.

- A white powder residue indicative of PD activity between the various motor leads was visible on the neutral leads.
- The neutral leads were found to be in close proximity to the HV leads and in actual physical contact with the 'C' phase sensor, which would also cause high electric stress and subsequent partial discharge activity.
- Insufficient spacing between the 'B' phase HV lead and ground produced PD that was visible with a CoronaScope.

- Shortening and isolation of the neutral leads.
- Neutral leads tied back into the winding away from the HV terminals and PD sensors.
- Insulating material placed between the 'B' phase HV lead and ground.

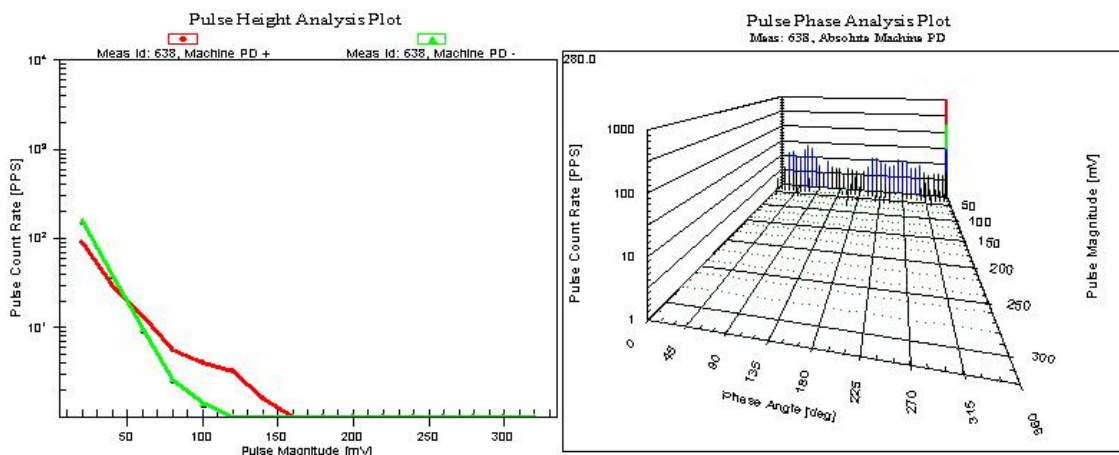
Figure 2. Online Partial Discharge Test After Remedial Work

Off-line PD testing on the motor following the repairs yielded no high magnitude PD.

The low-level classic PD, due to voids within the groundwall, was largely unchanged from levels prior to removal from service. On-line testing after the motor was returned to service showed the PD magnitudes were reduced by about forty times. With the sources of non-classic PD eliminated the overall winding condition is considered stable and the PD levels typical when compared to other windings of the same voltage class.
