## CASE STUDY: Detection and confirmation of endwinding problem in a rewind, large, hydrogen cooled turbo generator.

**Company:** A midwest U.S. utility

**Ratings:** 690MW Turbine Generator, 3600RPM, 20kV, Hydrogen cooled @ 59 PSI

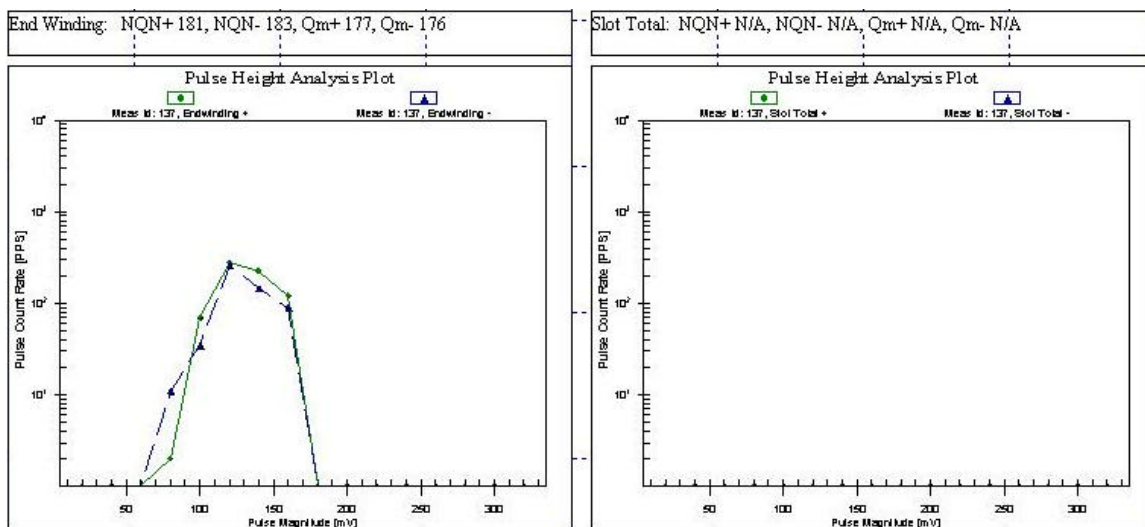
The source of high PD activity was identified and verified as occurring between the phase lead on C phase in slot 36 and the second coil leg down (top bar) on the A phase in slot 35. The plots below illustrate the 2D test results for Endwinding and Slot discharges acquired with the SSC in slot #36.

**Details:** After a rewind, periodic online testing utilizing both SSC's and 80pF EMC's revealed two trends; an overall downward trend in slot PD, an expected result following a rewind, and an alarmingly sharp rise in endwinding activity on C phase. A  $Q_m$  of 177 mV is higher than 98% of similar machines in the Iris database. The activity was suspected to be a single point of phase to ground activity on C phase that was also coupling to the other phases. In December 2001, a recommendation for close monitoring and visual inspection at the earliest convenience was made. In March 2002, Iris Power Engineering was requested by the customer to perform a visual inspection and off-line PD testing as required on the unit. During the offline testing a site of visible, high PD activity was quickly located using a Corona probe in conjunction with a stator wiring diagram.
