PROBLEMS IN HYDROGEN COOLED GENERATOR REVEALED BY HIGH PD ACTIVITY

Company: Midwest US Utility
Ratings: 173 MW, 18 kV, Hydrogen Cooled Turbine Generator, 3 years in operation

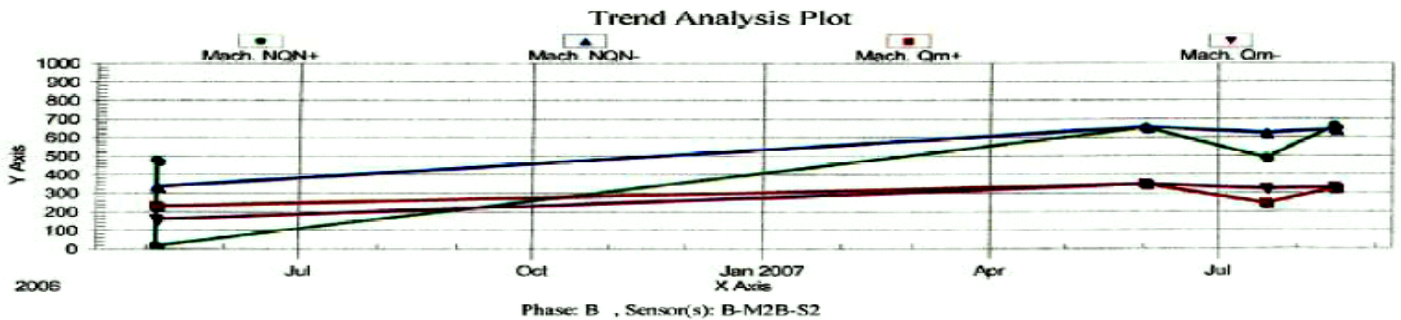
Figure 2. High PD Activity

Excerpt from report by the Lead Maintenance Engineer of the plant (October 2007). The alarm level from the Iris' 2005 Database Statistical Analysis is 224 mV for the 31-50 psi range.

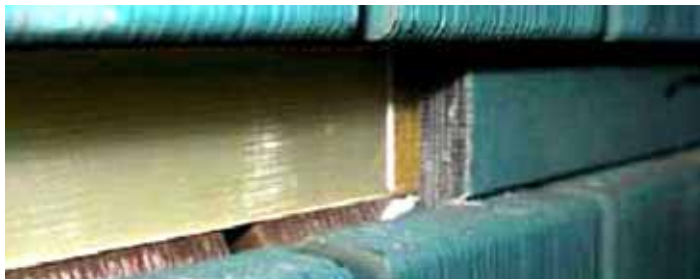
Figure 3. Incorrectly Installed Wedges
