DIAGNOSTIC NEWS

April 2010

Repairing Mechanical Damage to Stator Windings - Part 2

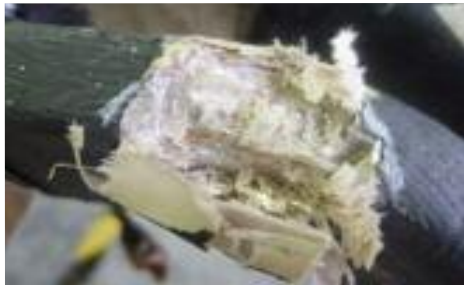
Impact damage to the groundwall insulation exposing the copper strands

Impact Damage: Where an object has hit the insulation with sufficient force to damage or crush the insulation. The full extent of the damage may be less evident, and the extent of the damage is not known until all the loose insulation has been removed.

- Inspect the damaged area and assess the extent of the damage.
- Remove all the loose and damaged insulation, back to the point where the insulation is solid.
- Impact Damage: Feather back (i.e. taper or chamfer) the insulation about 2 cm (3/4") all around the affected area. Feathering (tapering) back the insulation should reveal the different layers of exposed insulation.

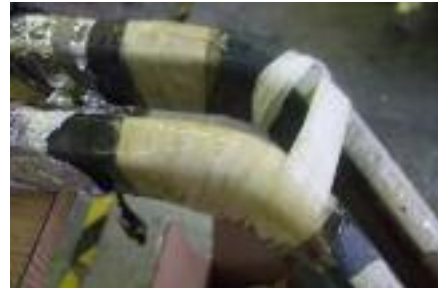
Completed insulation repair, awaiting application of the semi-con and grading coatings.

- Apply the appropriate number of mica tape layers, finishing with a final layer of glass tape and apply any stress coatings overtop as required.
